Preliminary monitoring results of threatened microbat mitigation and the latest microbat habitat features in heritage timber truss bridge design

NSW Roads and Maritime Services

Heritage bridge replacement

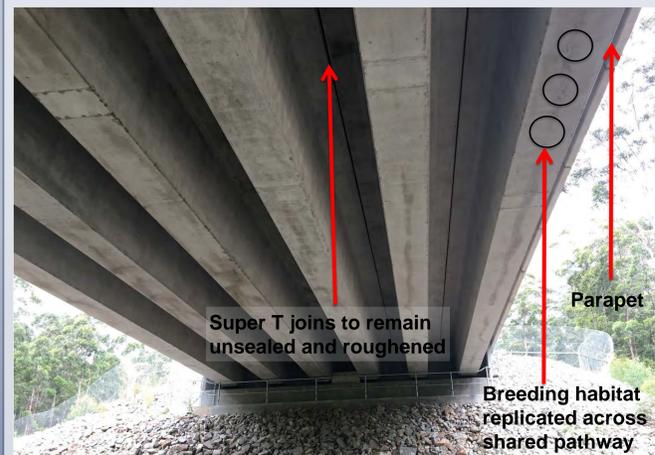
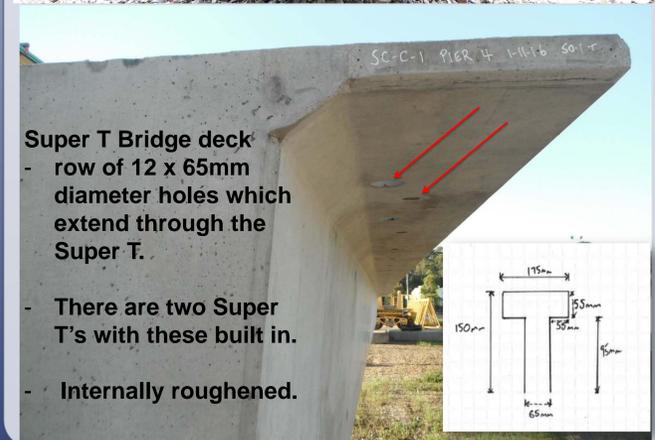
Microbat habitat between Super T girders and under shared path

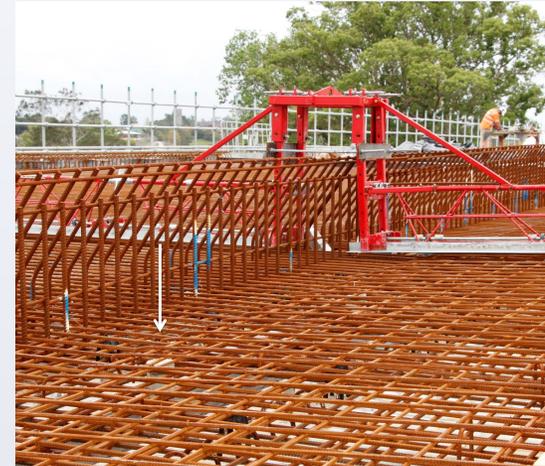
Bat caves are not easy to install on the bridge deck!

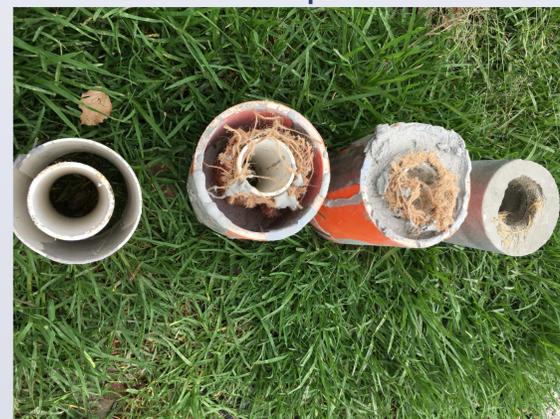
Bat caves are very fiddly to make so leave grab holes open!

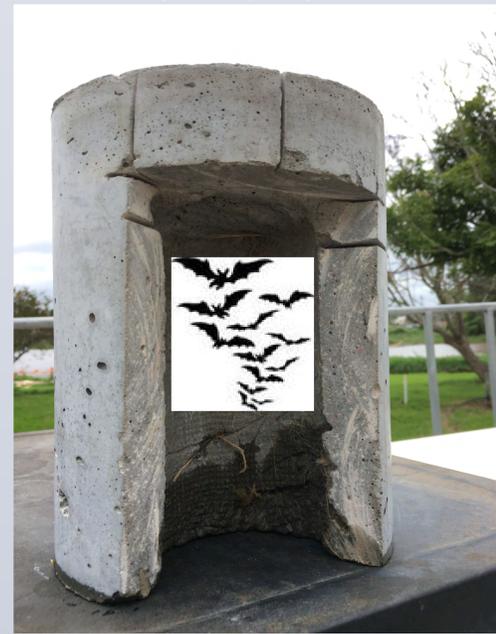
But they look pretty awesome!

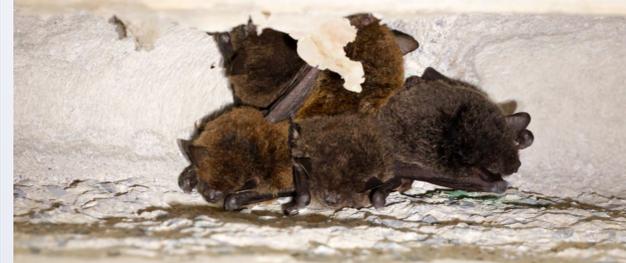
Five (5) Myotis found in the roughened parapet before construction finished.

Works had to stop within the vicinity of the bats and they were monitored daily until construction finished.

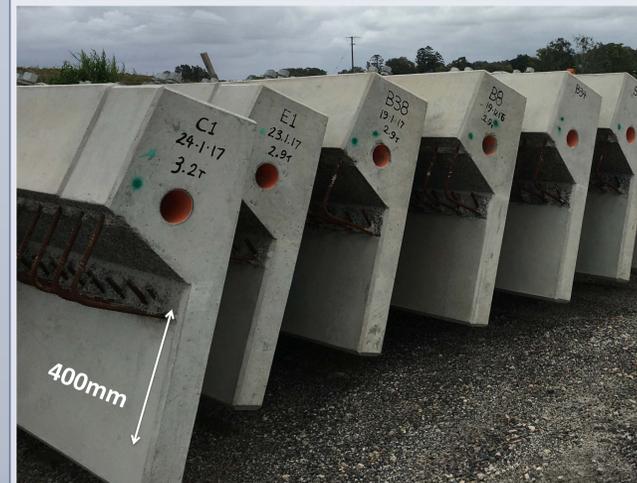
Use 'Rugasol' in the precast yard to roughen surfaces instead of using a scabbling gun.

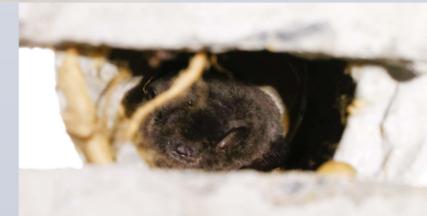
- Five (5) Myotis in the roughened parapet
- Eight (8) Myotis in the breeding habitat under the Super T deck but NOT under the shared pathway - WHY? 90mm vs 50mm diameter? Too exposed???

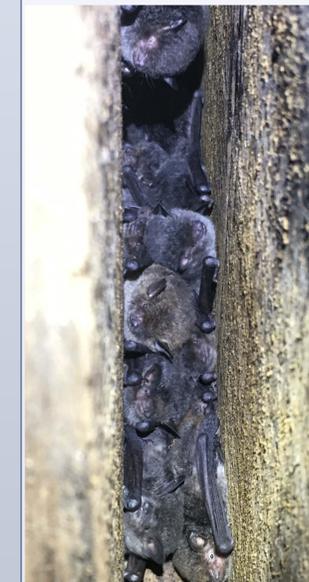
More monitoring needed before celebrating!

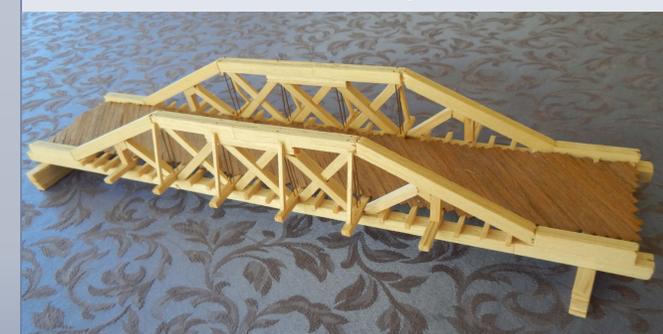
Objective: To replicate breeding habitat in TT Bridges when decking is permanently replaced with Stress Laminated Timber which has no gaps for microbats.

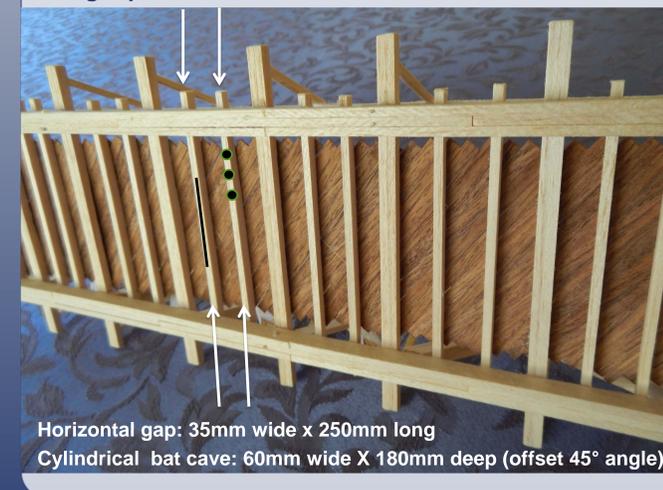
Drill cylindrical 'bat caves' and horizontal habitat into secondary cross girders at same dimensions as TT being replaced.
